Manhole Inspection Summary

Manhole # S31C__008MH

Location Address: **600 W MULBERRY ST**

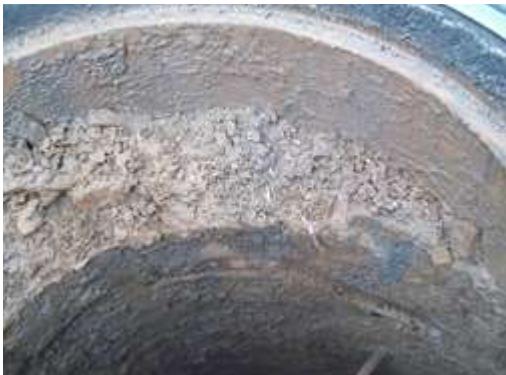
Defect 2

Condition: ☐ Sound ☒ **Cracked** ☐ Root Intrusion ☒ **Loose Brick** ☐ Deteriorated

cracked chimney

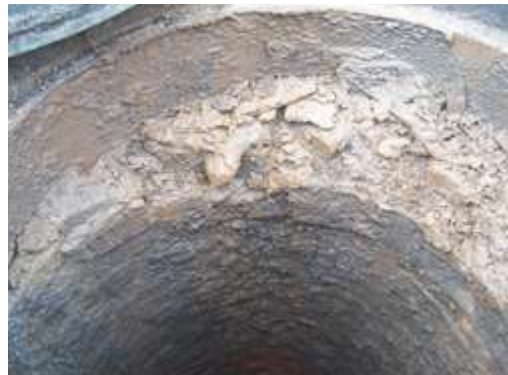
Defect 1

Frame Offset: **4** (in.) Condition: ☒ Sound ☐ Cracked ☐ Leaks

frame offset

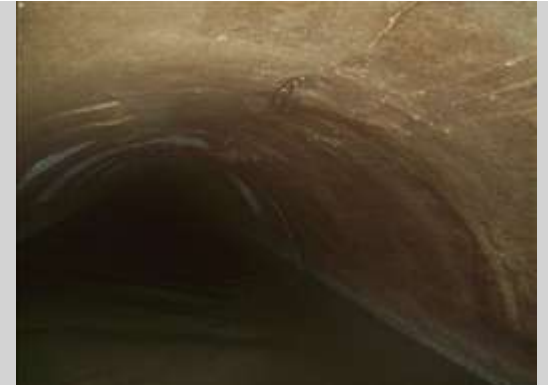
12 O'Clock Outflow

Pipe Height: (in.) Direct
Pipe Material: **Concrete** ☐ Pipe Lined
Invert Depth: **30.11** (ft.) Flow Characteristics: **Fast**
Deposits: ☐ None ☒ **Mud** ☐ Sludge ☒ **Debris** ☐ Grease
Silt Depth: **15** (in.) Deposits Extent: **Medium**
Infiltration: **None** Pipe Seal Cond: **Sound**

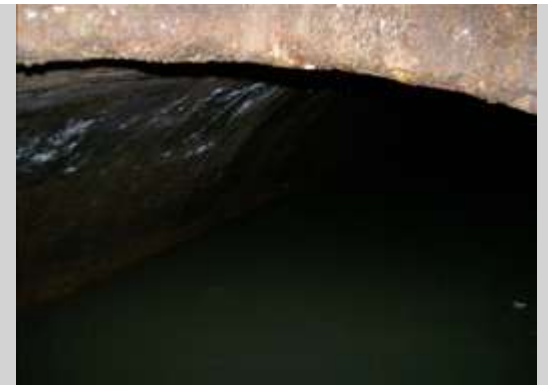
6 O'Clock Inflow

Pipe Height: (in.) Direct
Pipe Material: **Concrete** ☐ Pipe Lined
Invert Depth: **30.13** (ft.) Flow Characteristics: **Fast**
Deposits: ☐ None ☒ **Mud** ☐ Sludge ☒ **Debris** ☐ Grease
Silt Depth: **15** (in.) Deposits Extent: **Medium**
Infiltration: **None** Pipe Seal Cond: **Sound**
